MOisture detection in historic MAsonry

Methods to prevent and reduce dampness in masonry

Moisture monitoring experience in the old town of Genoa (Italy)

The study case of St Matteo Abbey

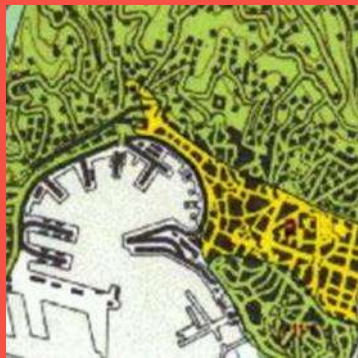
Pliocene marls
and alluvial clays

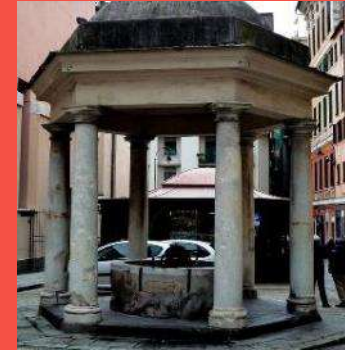
historical aqueduct
1295-1355

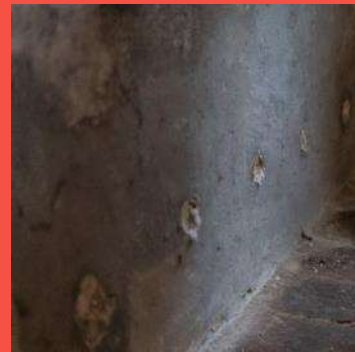
Superintendence 1992
chemical barrier

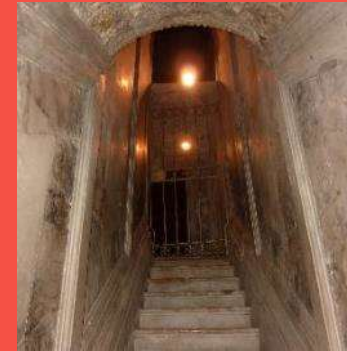
Montorsoli 1540
air duct

The Abbey has had serious problems with rising damp both in the hall. Montorsoli improved the crypt's aeration with an air duct reaching the roof and grates connecting the crypt and the hall. Several authors complain about humidity problems over time (1768, 1934).

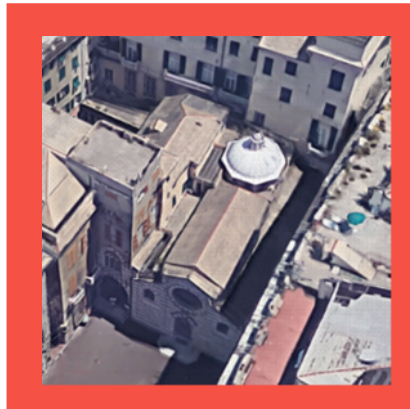
difference in level
about 10 m

In the Abbey's case, the overland flow may be occurring exactly around the church's foundations, as demonstrated by the fact that the main sections of degradation are within the first two metres of the church's walls, as well as in the crypt and the room underneath, which are both completely interred.

The cause of the humidity is a consequence of the geo-morphological context of the Abbey and its surrounding area.

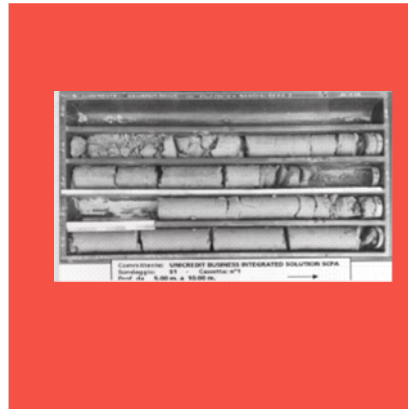
Argille di Ortovero
e marl

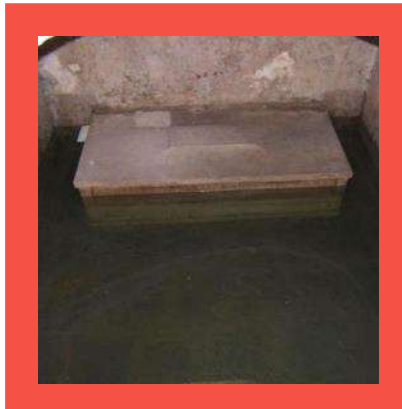
flood in 2014
60 cm of water

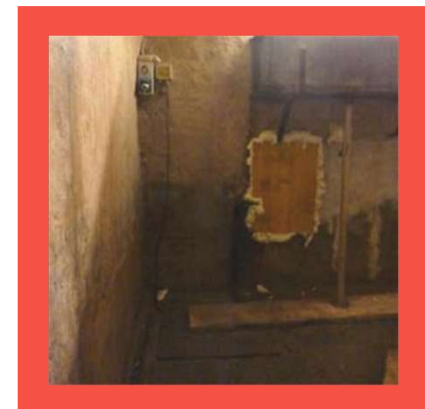
walled conduit

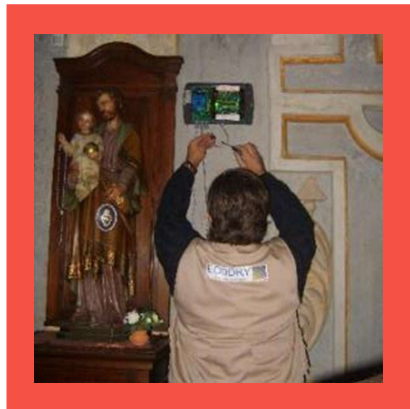
device installation
5/12/2012

In 2012 Ecodyr Italia installed 5 Zeta III devices in the Abbey, including 4 in the church and 1 in the room under the crypt.

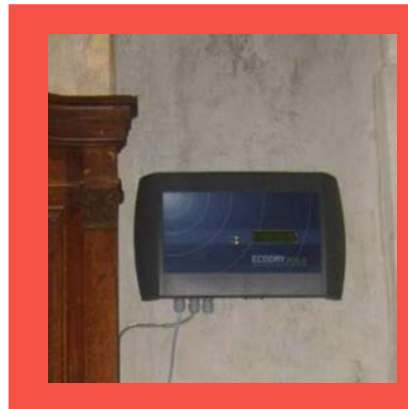
Zeta III device

The Ecodyr devices emit long-wave radio-electro-magnetic pulses which, associated with a bimodal magnetic field ($<40\text{nT}$ at a distance of 0.5m), intervene in the ascensional and transversal processes of the water molecules within the entire wall structure.

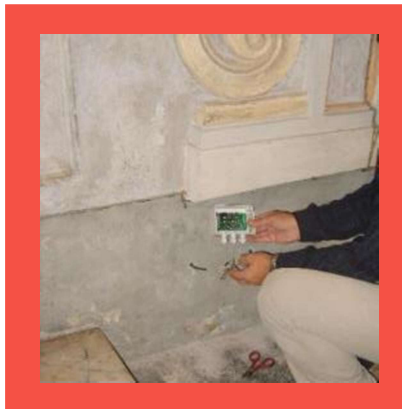
sensor probes
installation

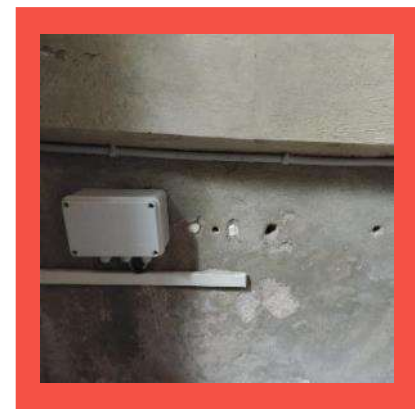
Biodom Control
data logger

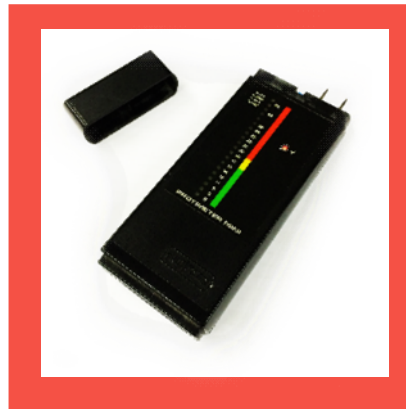
Electrical Resistance method

There were four types moisture measurements: environmental, superficial (**Electrical Resistance method**), sub-superficial (Electrical Capacitance method) and deep measurements (**Gravimetric method**).

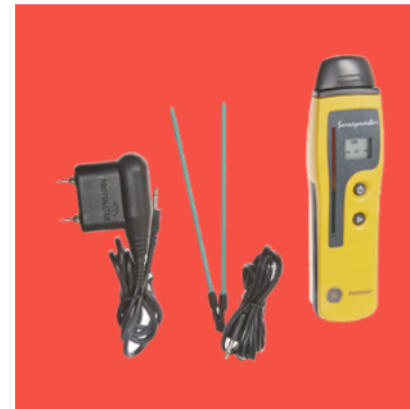
Electrical Capacitance method

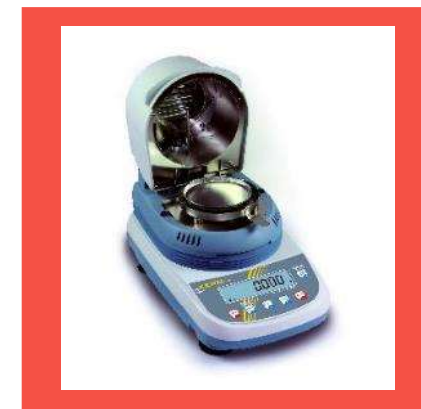
Gravimetric method

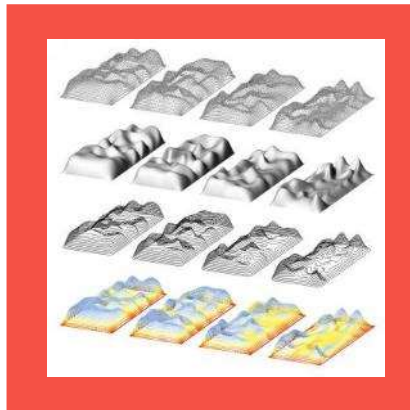
Software Rhinoceros3D
- plug-in Grasshopper

The 3D survey and the algorithm created expressly for the present case accelerated the work process and showed the phenomena observed in a clear form.

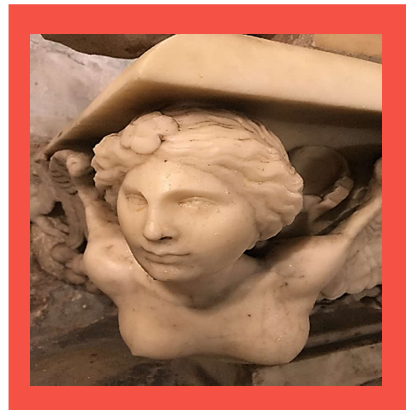
Moisture
condensation

The problem of moisture condensation is very evident in the church, so much that it appears overwhelmingly in the summer months on the numerous marble surfaces that cover and decorate the interior of the church and the crypt.

The monitoring of surface moisture has suffered greatly from the condensation during the spring-summer months, so as to provide periodically higher relative readings in the months of June-July compared to the months of January and February.

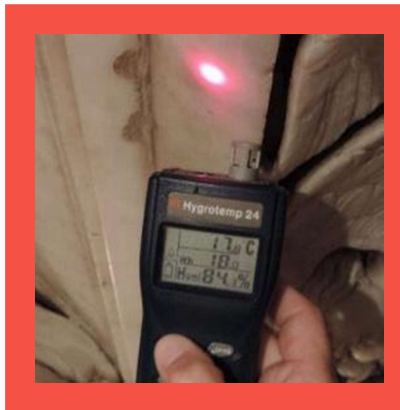
Relative air Humidity
> 80%

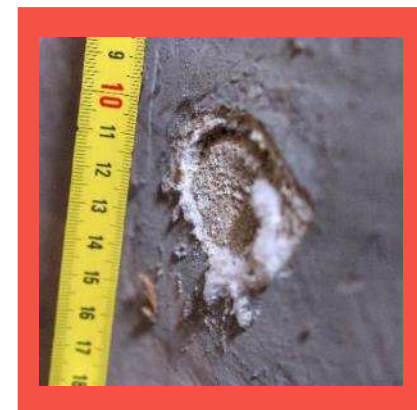
salt efflorescence
nitrates and sulphates

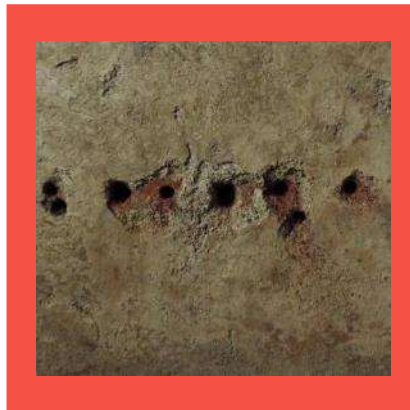
destructive tests

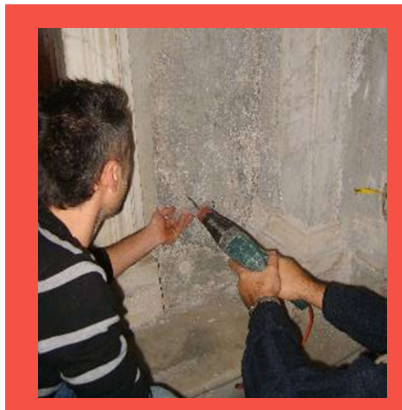
Two depths:
4-5 and 14-15 cm

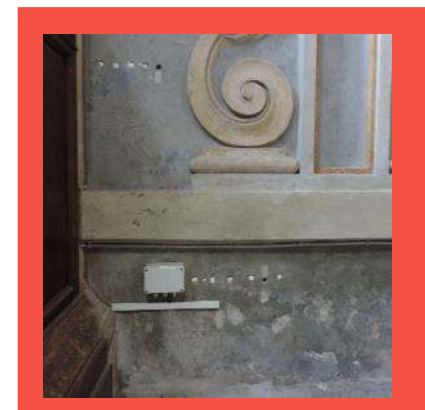
two heights:
30-40 and 100-110 cm

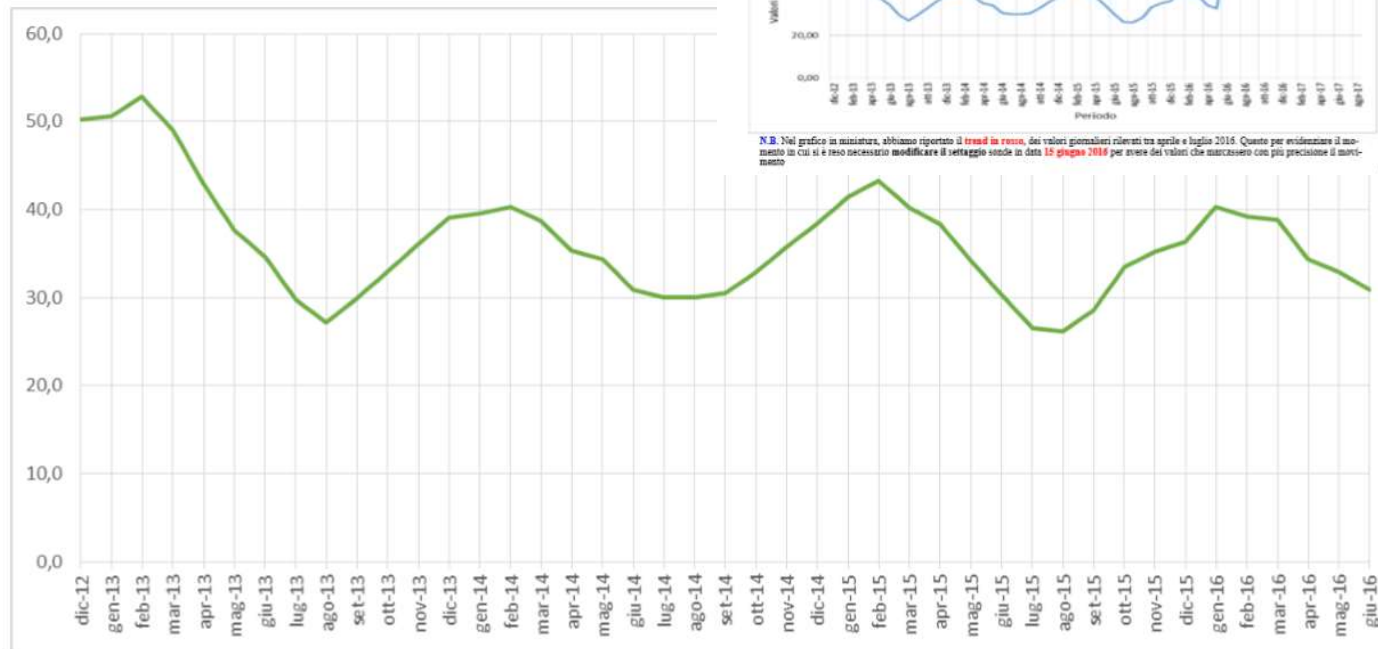
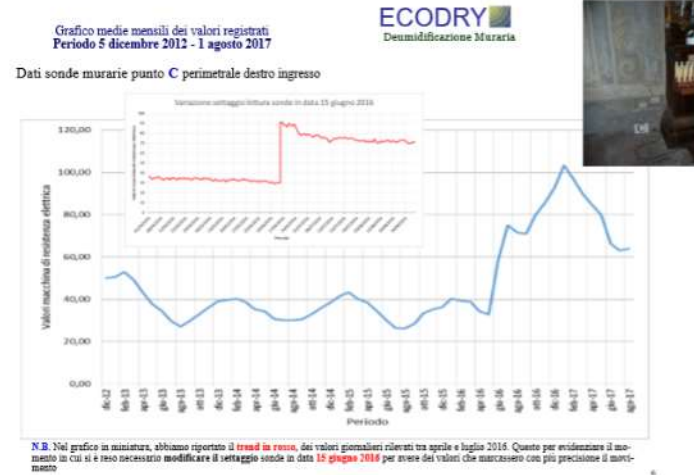
Grafico medie mensili dei valori registrati
Periodo 5 dicembre 2012 - 15 giugno 2016

Dati sonde murarie punto C perimetrale destro ingresso

resistenza elettrica

The only continuous monitoring, performed in this case, is the one made by Ecodry Italia with the probes-inserted in the walls of the hall and the crypt. Despite the diversity of electrical resistance values recorded from point to point, there is an annual periodicity of the data that corresponds to a recurring phenomenon.

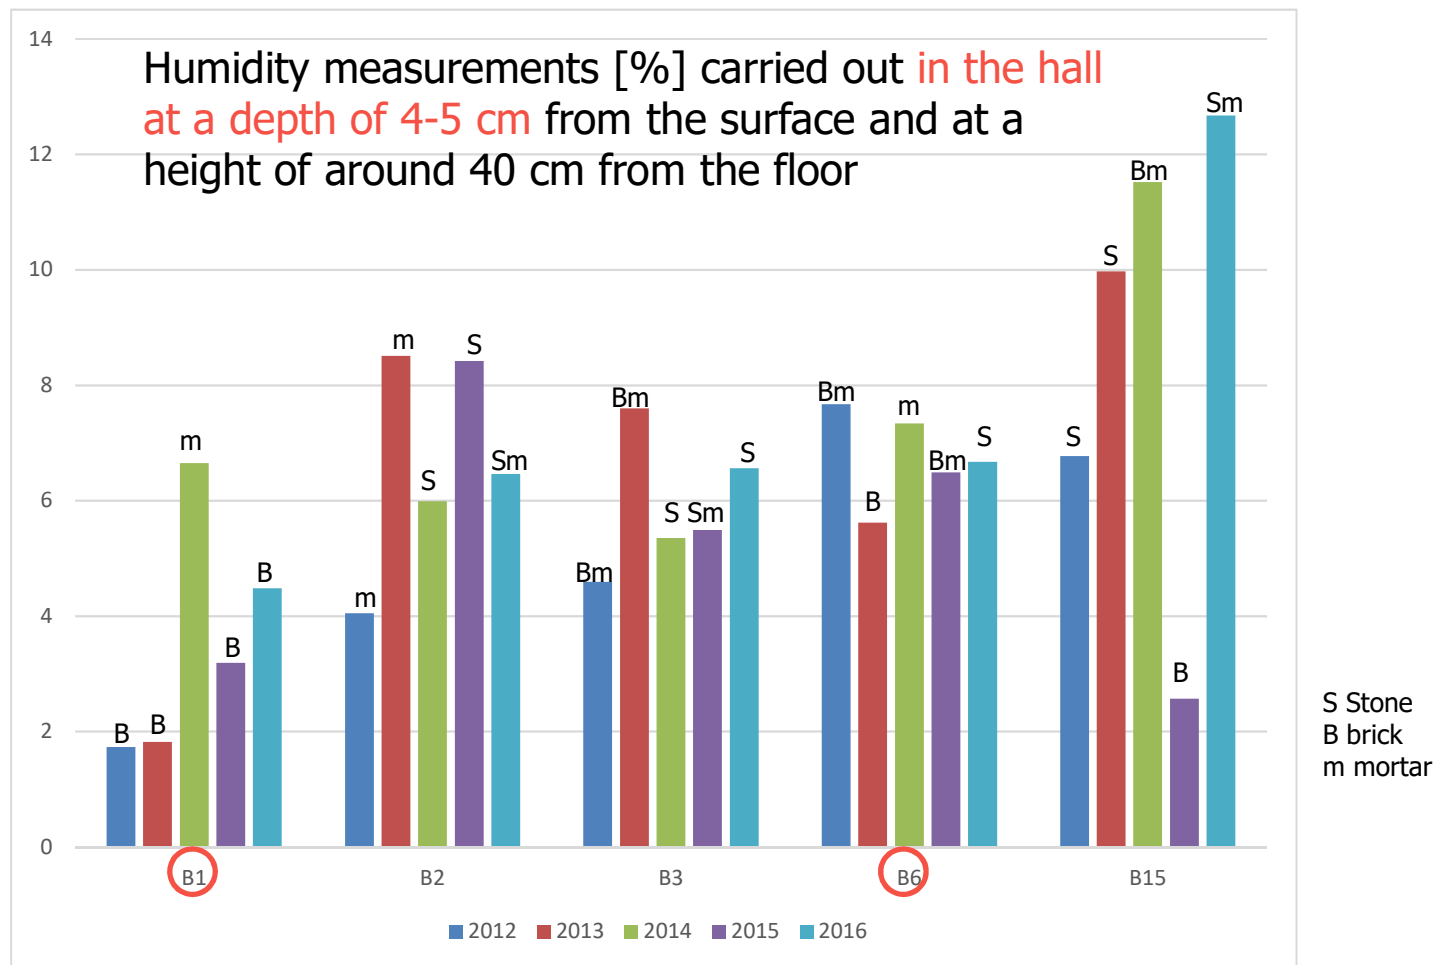
Gravimetric method

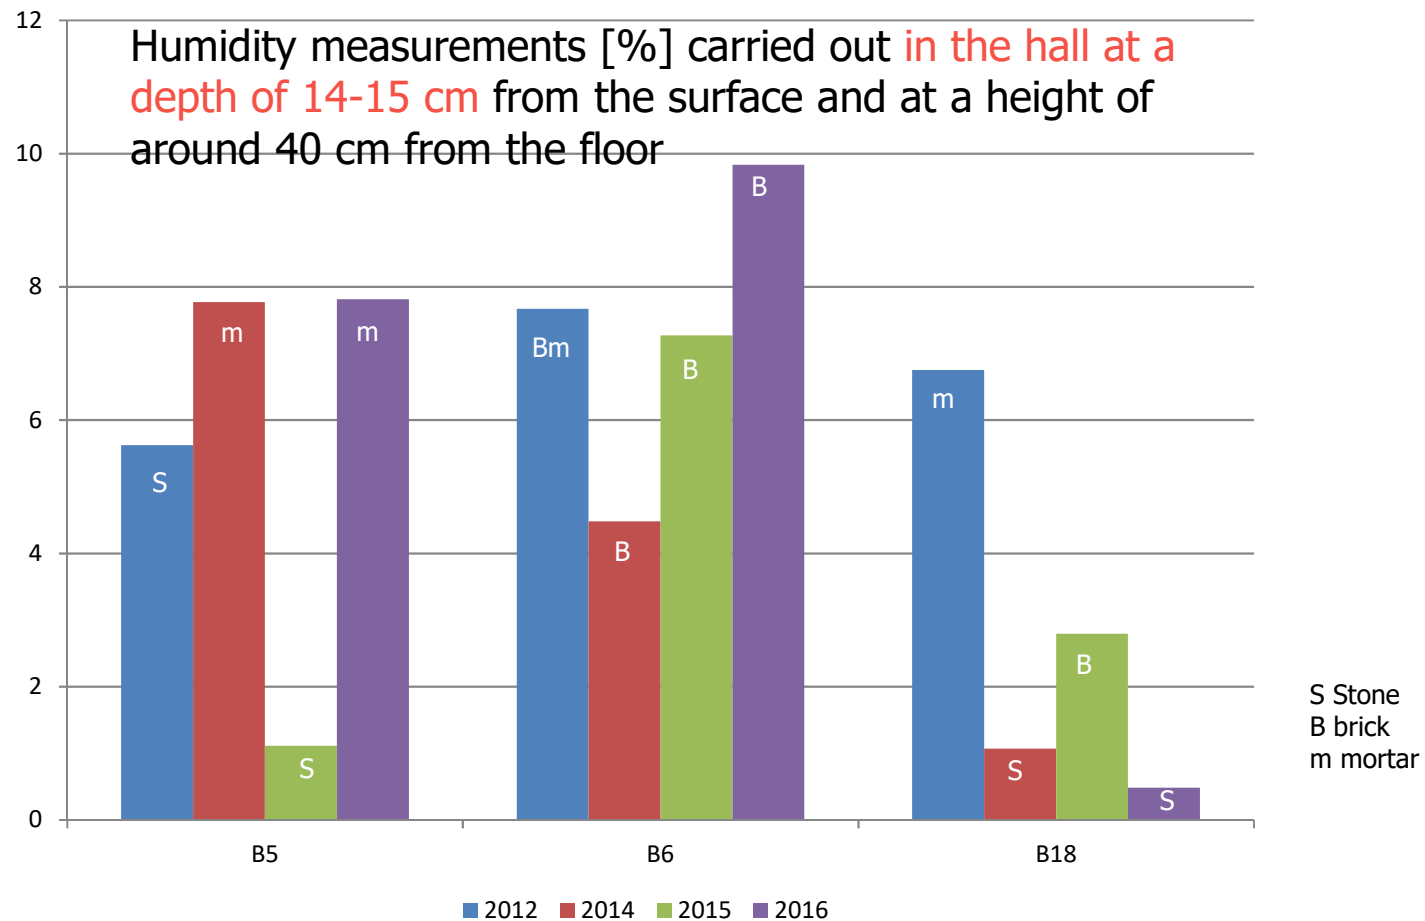
Gravimetric method

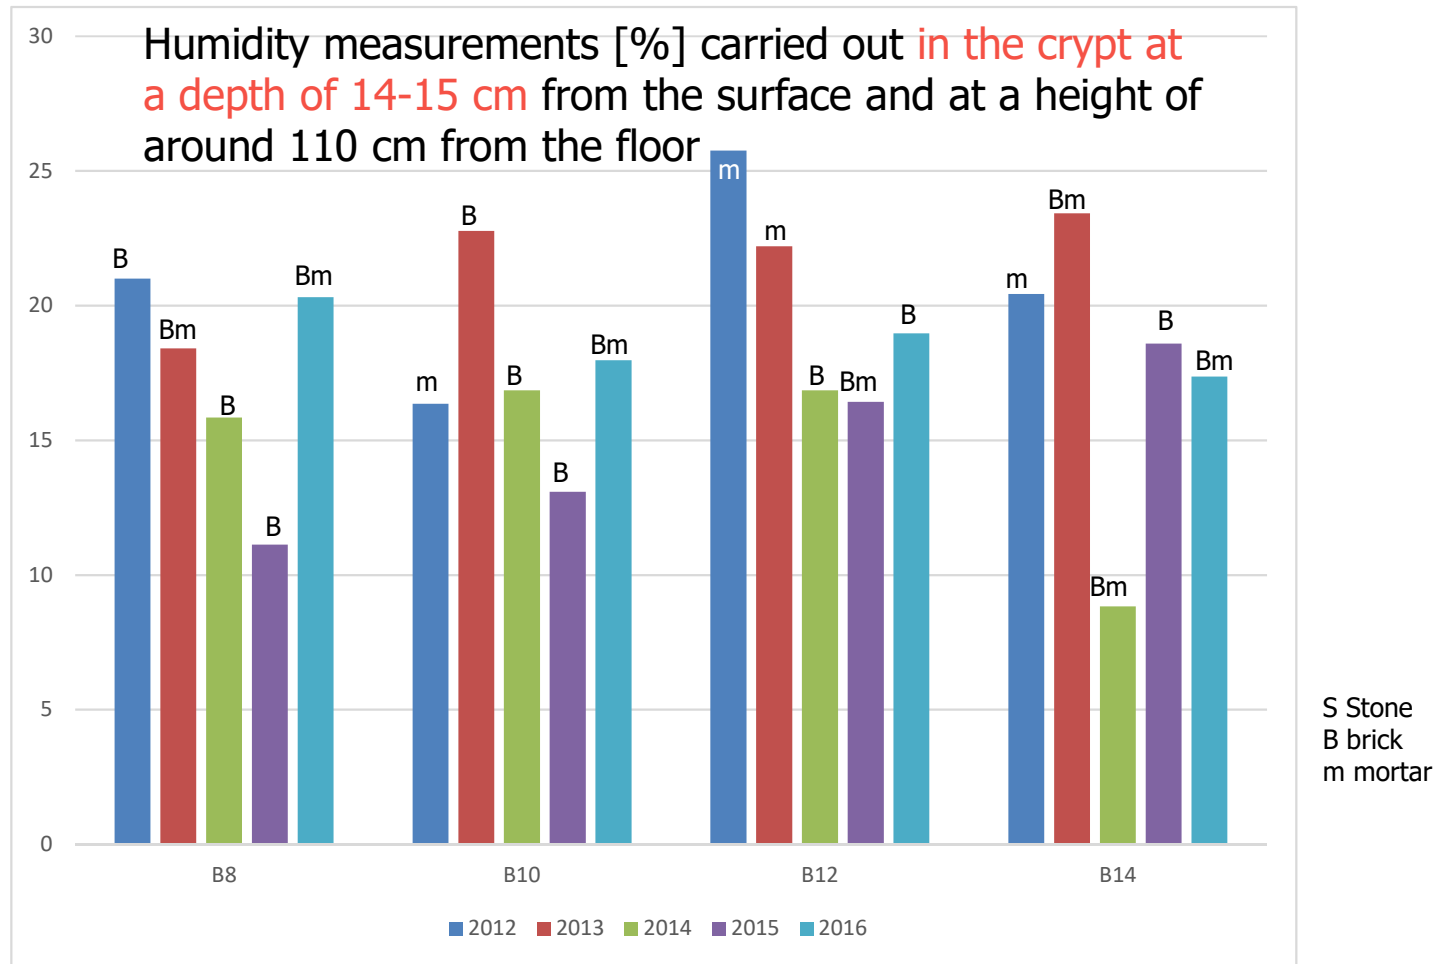
Gravimetric method

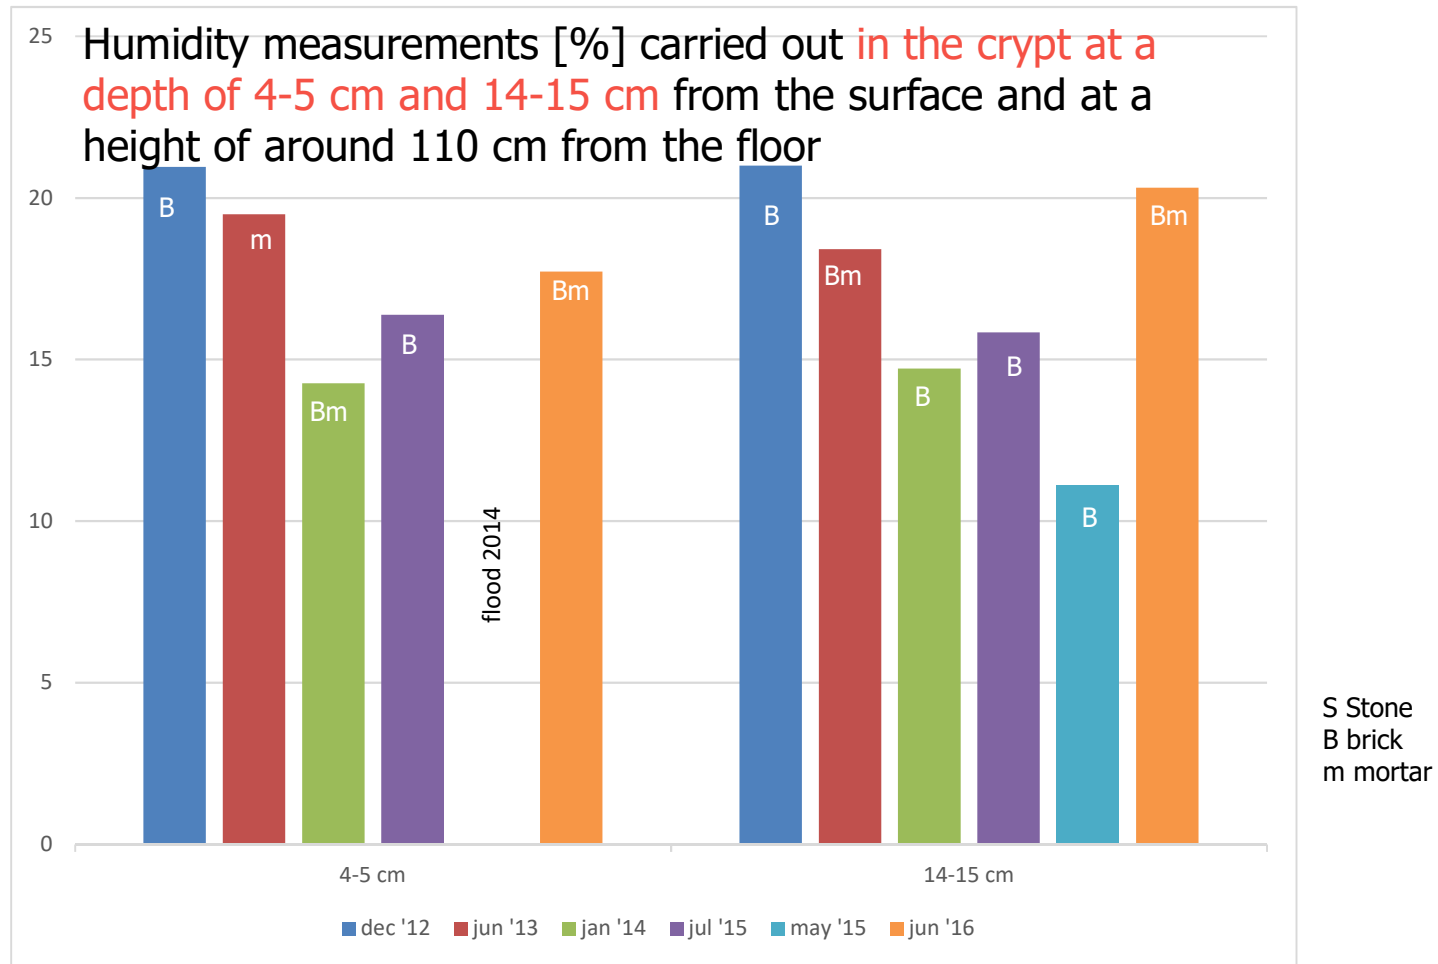
Gravimetric method
